# Gladstone Views Primary School

Community Forum 15 December 2017

## Frequently Asked Questions

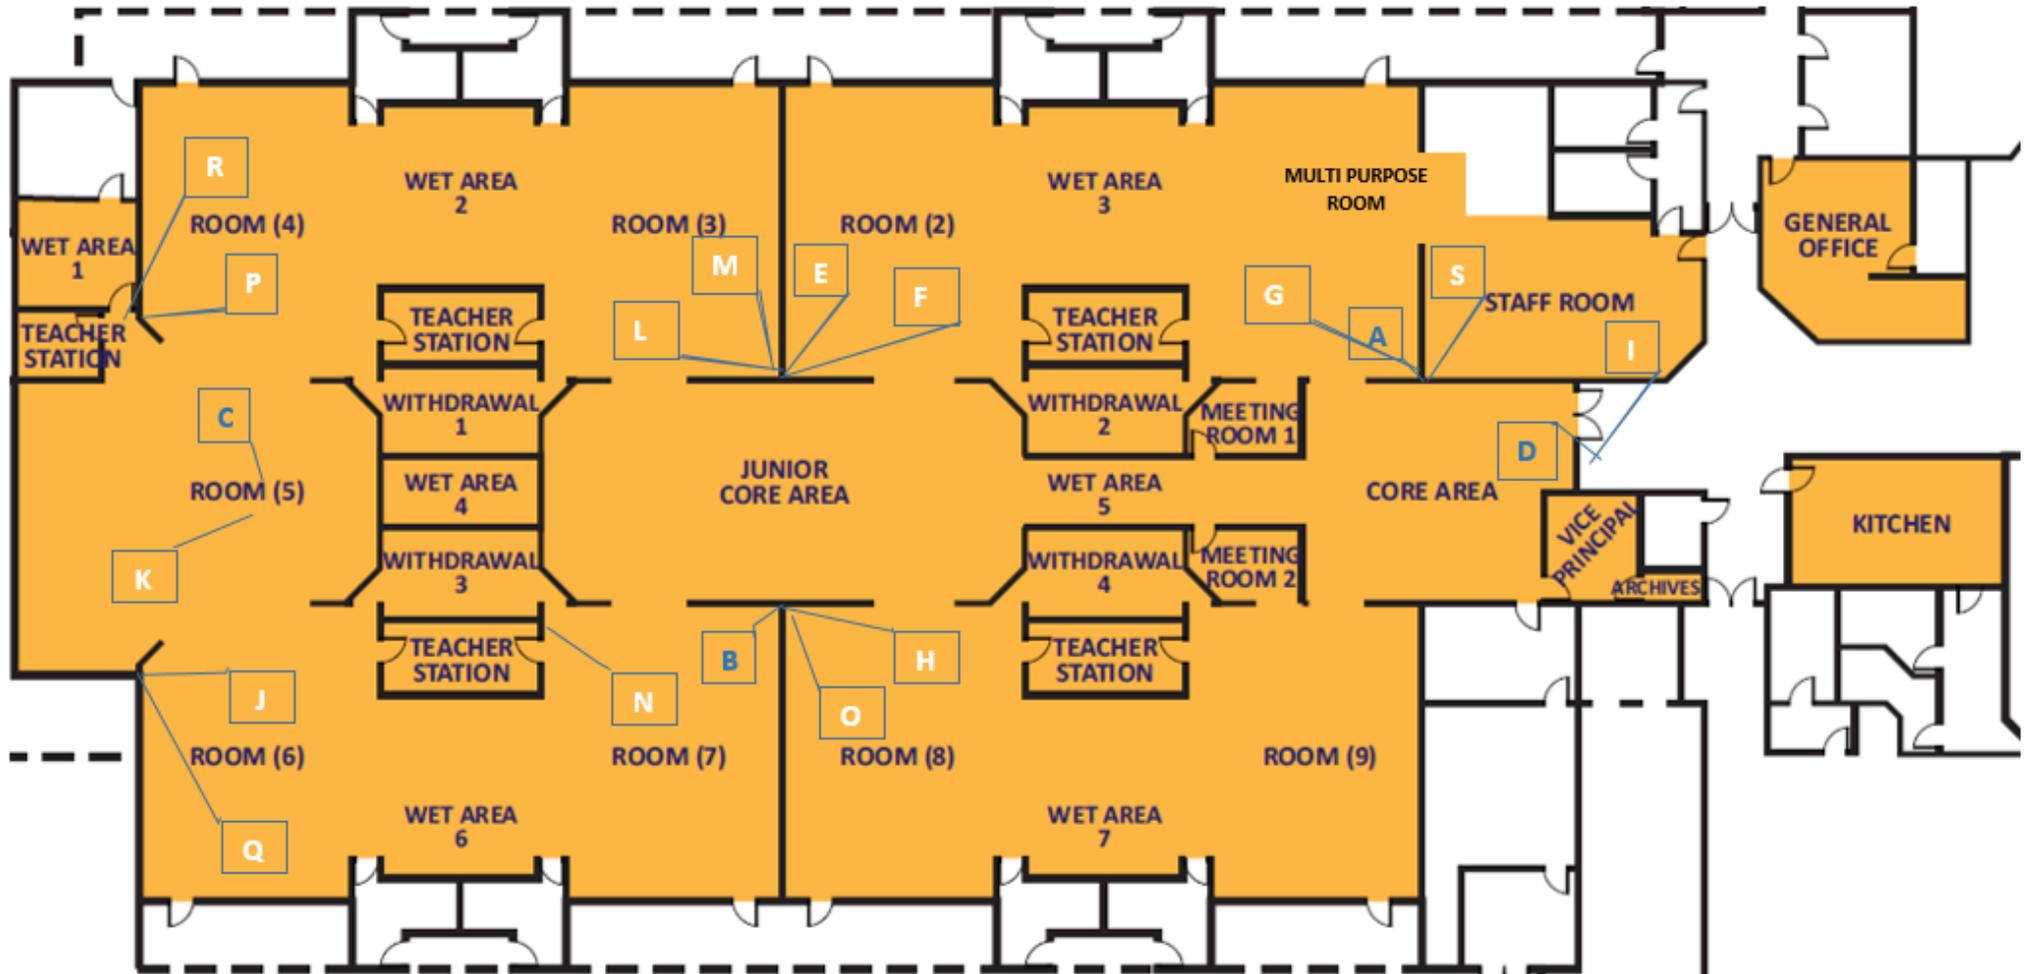
## Attachment 1 – Map of locations where dust samples were taken

ID	Room	Location	Result/s	Status
A	Multi-purpose	South-eastern corner	Beneath infill panels – Dust on carpet (on tape)	<b>Positive</b>
B	Room (7)	North-eastern corner	Infill panels – Dust on carpet (on tape)	<b>Positive</b>
C	Room (5)	Centre of Room	Beneath infill panels – Dust on rafter	<b>Positive</b>
D	45 Core Area	Outside 52 Vice Prin	Beneath infill panels – Dust on rafter	<b>Positive</b>
E	Room (2)	South-western corner	Beneath infill panels – Dust to carpet	Negative
F	Room (2)	South-western corner	Beneath infill panels – Dust on rafter	Negative
G	Multi-purpose	South-eastern corner	Beneath infill panels – Dust on rafter	Negative
H	Room (8)	North-western corner	Beneath infill panels – Dust on carpet (on tape)	Negative
I	45 Core Area	Outside 52 Vice Prin	Beneath infill panels – Dust on carpet (on tape)	Negative
J	Room (6)	North-western	Beneath infill panels – Dust on carpet (on tape)	Negative
K	Room (5)	Centre of Room	Beneath infill panels – Dust on carpet (on tape)	Negative

L	Room (3)	South-eastern corner	Beneath infill panels – Dust on carpet	Negative
M	Room (3)	South-eastern corner	Beneath infill panels – Dust on rafter	Negative
N	Room (7)	North-eastern corner	Beneath infill panels – Dust on rafter	Negative
O	Room (8)	North-western corner	Beneath infill panels – Dust on rafter	Negative
P	Room (4)	South-western corner	Beneath infill panels – Dust on carpet (on tape)	Negative
Q	Room (6)	North-western corner	Beneath infill panels – Dust on rafter	Negative
R	Room (4)	South-western corner	Beneath infill panels – Dust on rafter	Negative
S	50 Staff Room	South-western corner	Beneath infill panels – Dust on rafter	Negative
